Roanoke, Town of  
(John Conrad House)  
Roanoke  
Lewis County  
West Virginia

HABS No. WV-209-H

WRITTEN HISTORICAL AND DESCRIPTIVE DATA

ROANOKE, TOWN OF  
(John Conrad House)

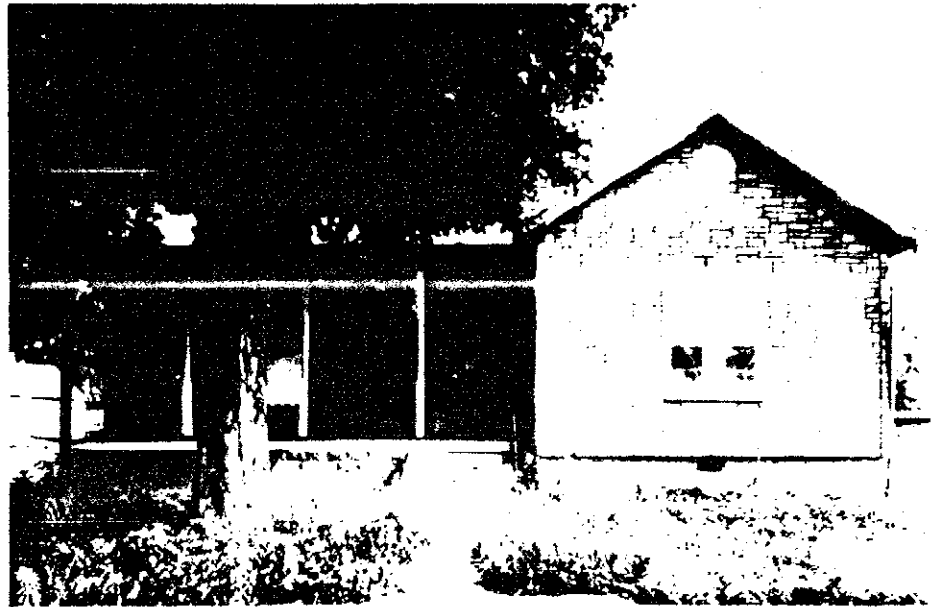
Perspective control photograph of the northwest elevation of the Conrad House in 1981.

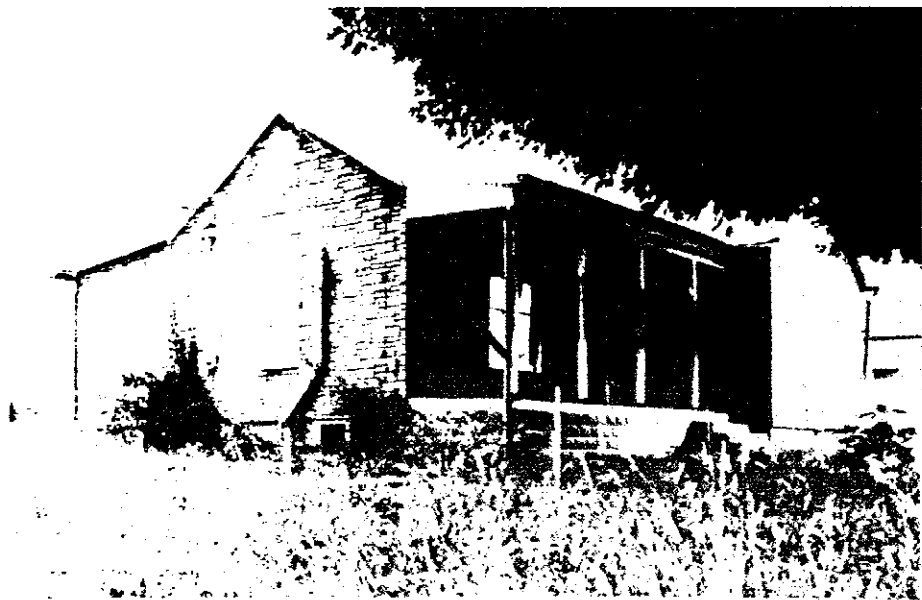
Perspective control photograph of the northwest and northeast elevations of the Conrad House.

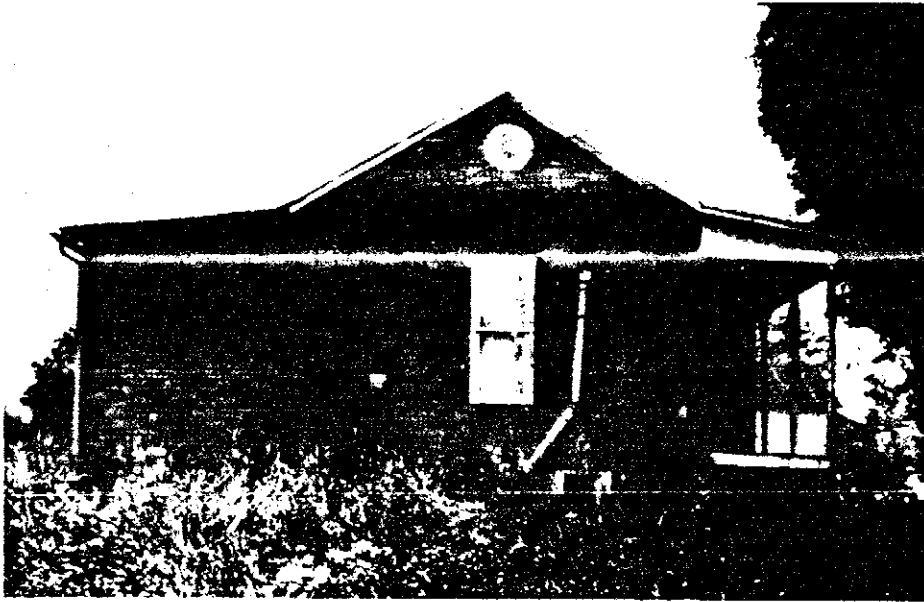
Perspective control photograph of the northeast elevation

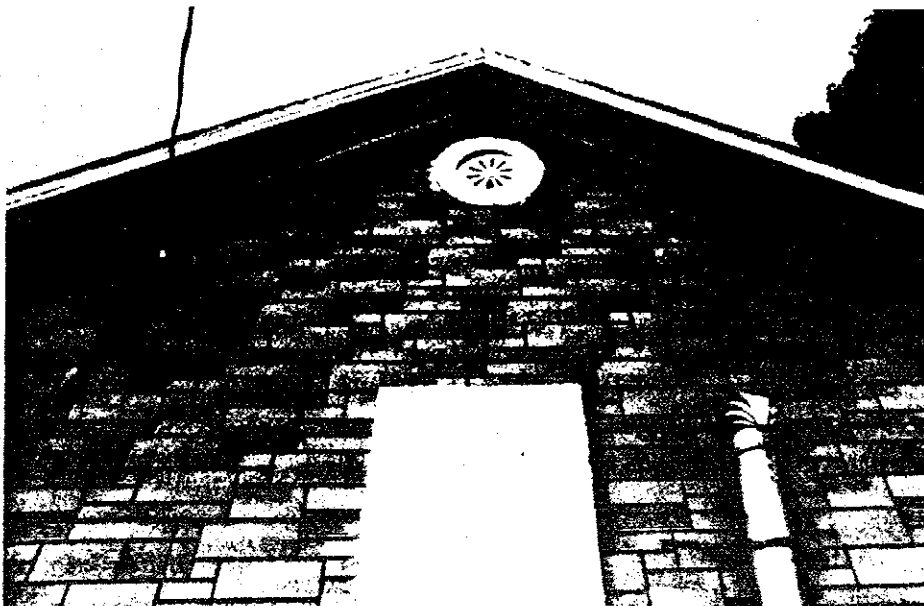
Close-up of circular ventilation louver in the northeast elevation  
Note stove flue at bottom right.

Roof: The roof is a medium-pitch gable variety covered with raised seam sheet metal roofing painted silver and measuring 1'0" on center. Eaves and raking trim consist of a boxed cornice, and the eaves have sheet metal gutters and downspouts. Ventilation for the crawl space area is provided by a rectangular-shaped louver near the roof peak in the southeast wall and circular-shaped louvers in the northwest and northeast walls.

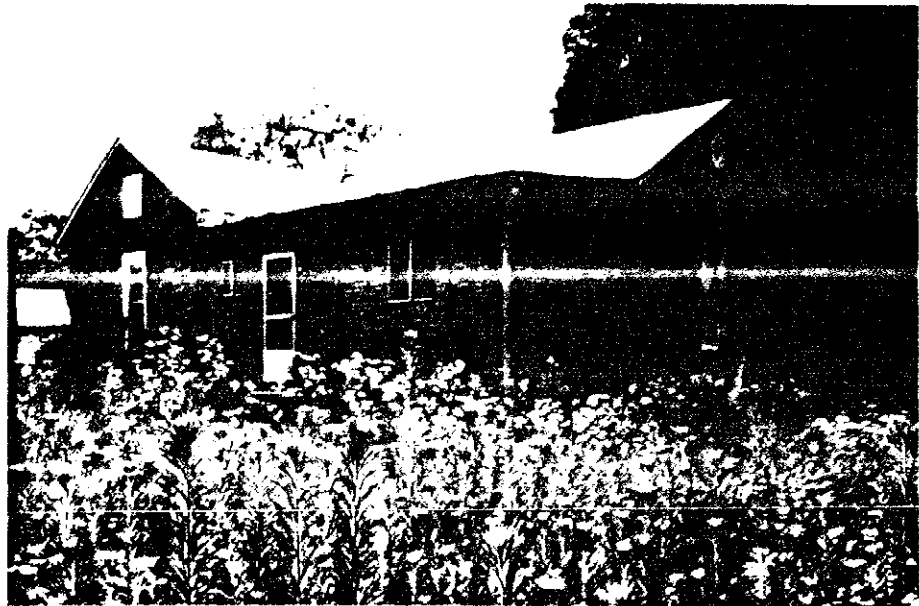
Perspective control photograph of northeast and southeast elevations of the Conrad House in 1981. This photograph clearly shows the major architectural components of this structure.

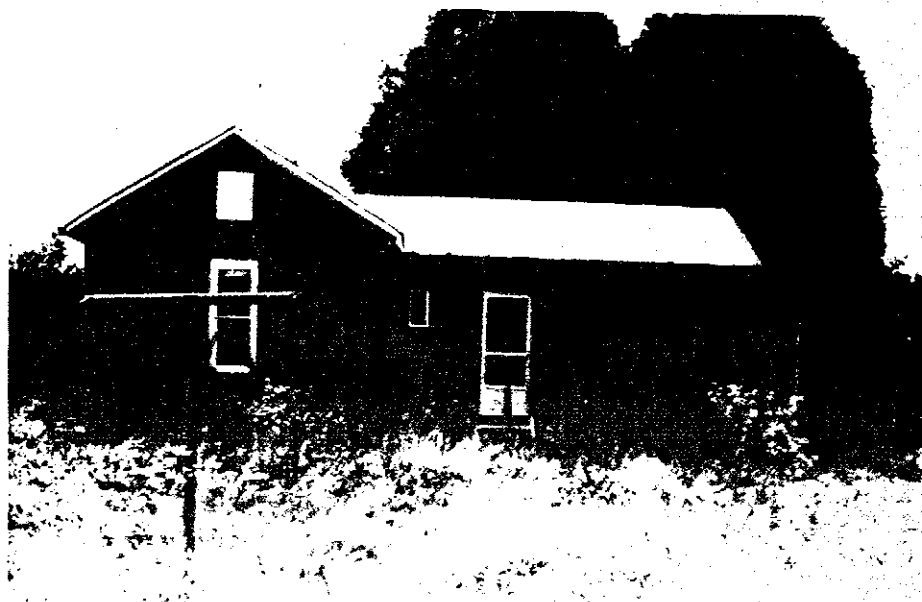
Perspective control photograph of the southeast elevation of the Conrad House. Note the rectangular ventilation louver below the roof peak.

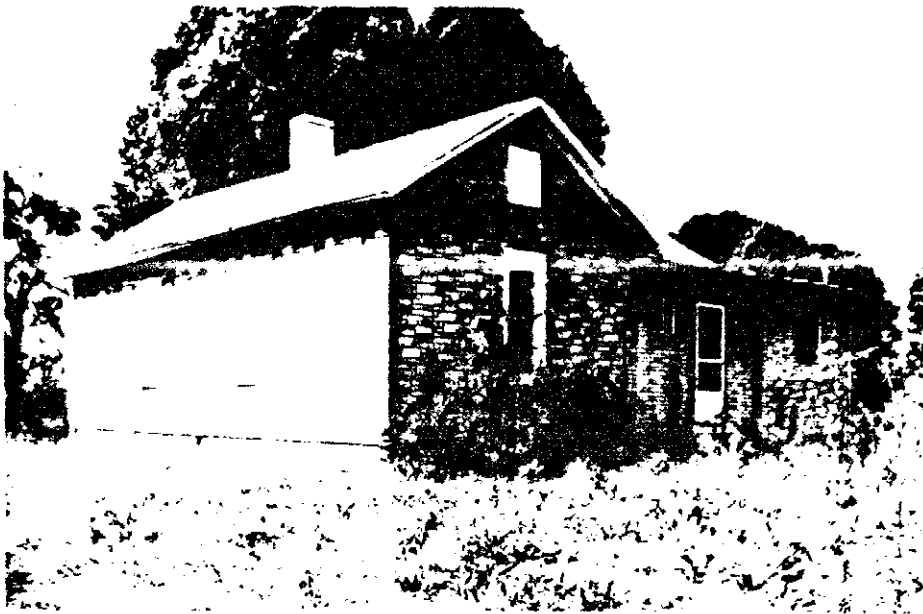
Perspective control photograph of the southeast and southwest elevations

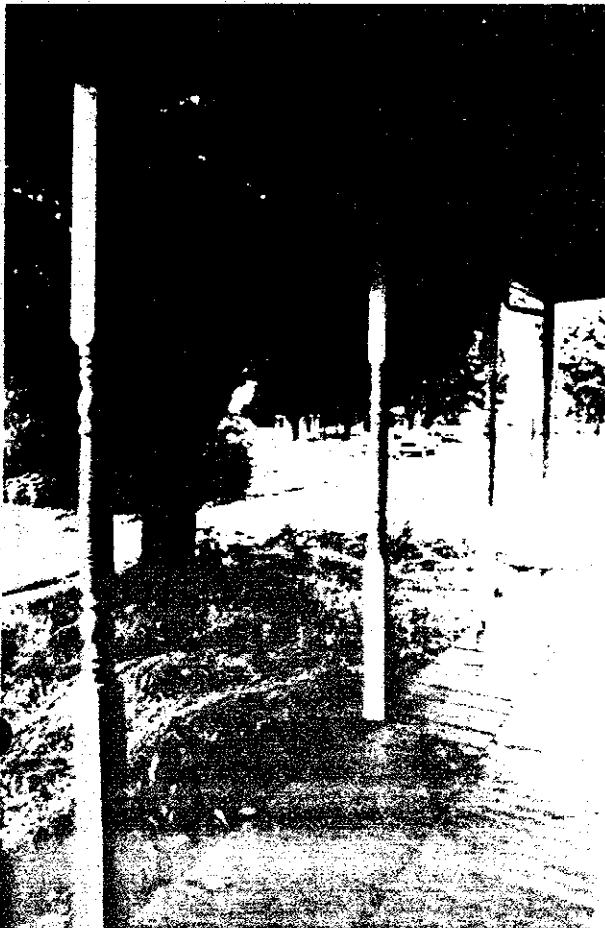
Close-up of porch column  
detail on the Conrad House  
in 1981. This picture looks generally  
north. The road just beyond the tree  
in the photograph is West Virginia  
County Route 23/5, the old Weston and  
Gauley Bridge Turnpike.

Porch: A 6' wide x 23' long porch with a 9'1 1/2" ceiling is positioned along the northwest side of the tee . The deck, which is 3' above grade, is composed of 3 1/2" tongue and groove boards painted gray. Access to the deck is via four poured concrete steps (60" wide x 13" tread x 7" rise) plus an 8 1/4" riser. The shed roof that covers the porch is supported by four white-painted, turned columns and is covered with raised seam sheet metal roofing; the porch ceiling is of 2 1/2" tongue and groove boards painted white.

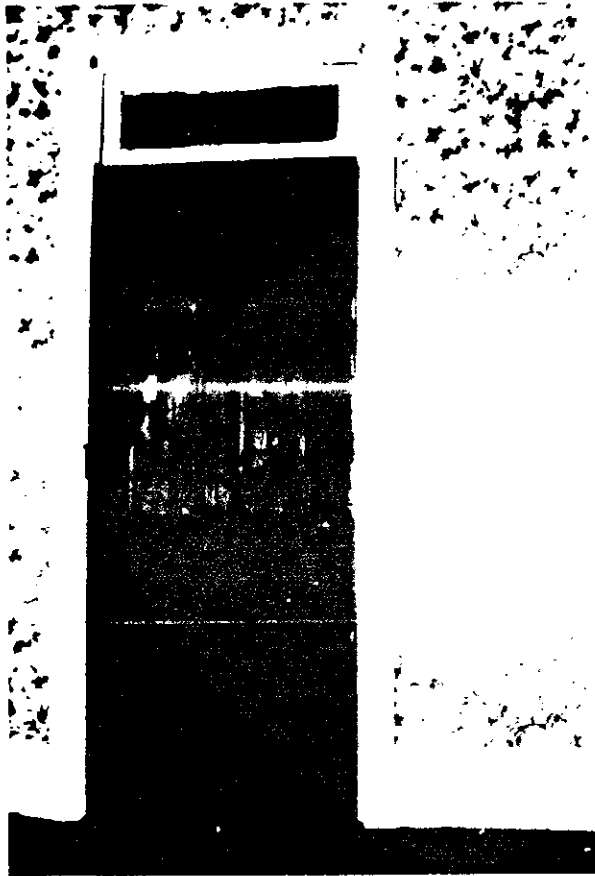
Close-up of Room 1 to exterior door in the northeast elevation of the Conrad House in 1981. Note transom above door. This room once served as the U.S. Post Office in Roanoke before World War I.

It should be noted that according to Bertha Brinkley (1982, pers. comm.), Rondall Brinkley's sister-in-law, and Ross Brinkley, Rondall's brother (1982, pers. comm.) the Conrad House once served as the Roanoke U.S. Post Office. According to these informants, the post office was in Room 1. This undoubtedly explains the atypical arrangement of two "main" entrances on the northwest side of the structure.

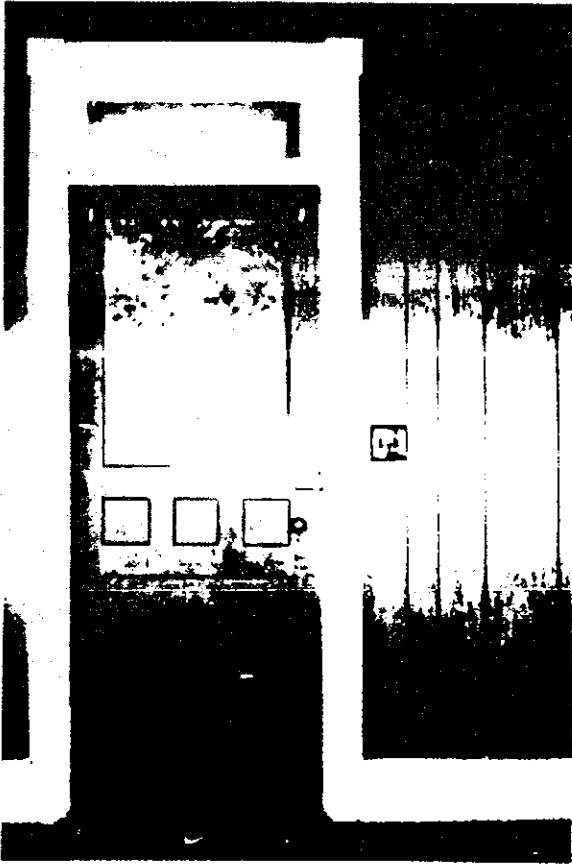
Close-up of Room 2 to  
exterior door in the northwest eleva-  
tion

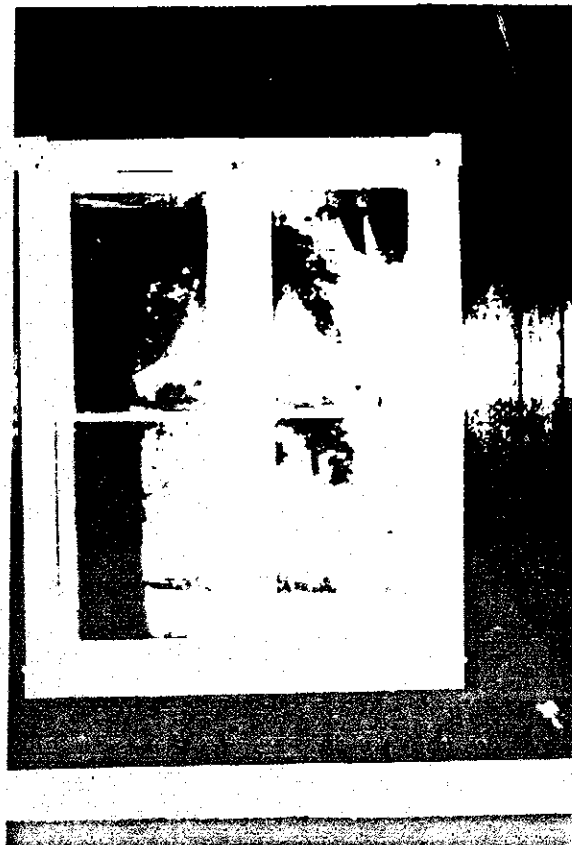
Close-up of paired double  
hung windows in the northwest eleva-  
tion of Room 2

Position*	Style	Opening	Size of Pane	Number of Panes	Type of Sill	Interior Surround Trim	Exterior Surround Trim
NORTHWEST WALL Left to right	paired double hung	24 1/4" x 69 1/2"	20" x 32"	1/1	slip	4 1/2" mold	1 1/2" plain boards
	paired double hung	24 1/4" x 69 1/2"	20" x 23"	1/1	slip	4 1/2" mold	1 1/2" plain boards
NORTHEAST WALL Left to right	double hung	28 1/4" x 70 1/4"	24" x 32"	1/1	slip	4 1/2" mold	1 1/2" plain boards
SOUTHEAST WALL Left to right	double hung	28 1/4" x 69"	24" x 32"	1/1	slip	4 1/2" mold	1 1/2" plain boards
	vertical sliding (modern)	24" x 24"	15 1/2"x21 1/4"	1 by 1	—	2 1/8" ranch mold	2 3/8" ranch mold
	vertical sliding (modern)	35 1/2" x 33 1/4"	16" x 33"	1 by 1	—	2 3/8" ranch mold	2 3/8" ranch mold

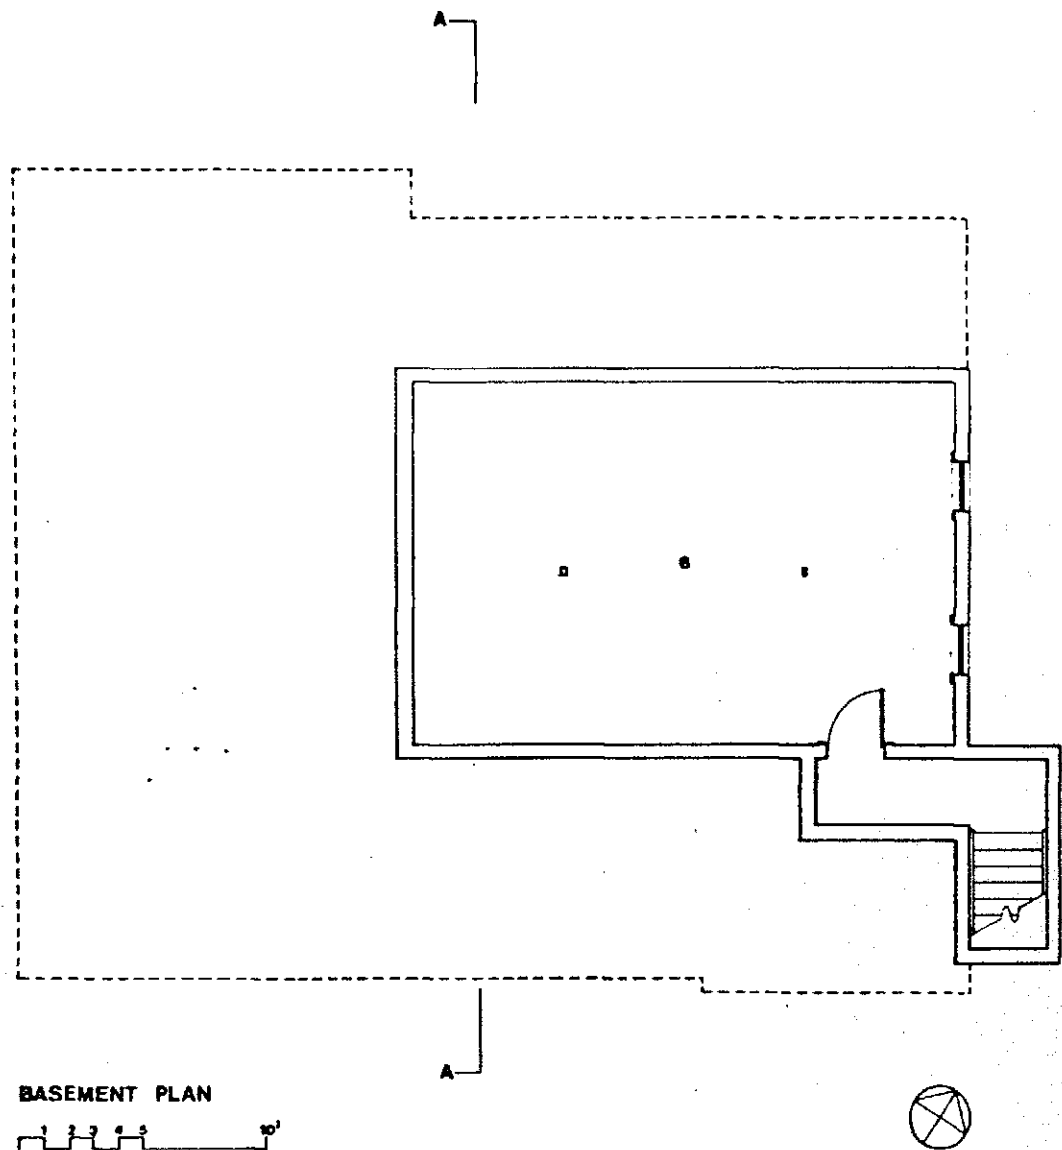
Cellar (Room 6) floor plan of the Conrad House

#### Interior Description: Room 6

Function: cellar.

Dimensions: 14'7" x 22'1"; 6'10" ceiling.

Wallcovering: 8" concrete blocks, unfinished.

Floorcovering: poured concrete.

Ceiling: 2" x 8" joists on approximately 2' centers.

Stairways: 2'10" x 7'11" open stairwell built of 8" concrete blocks located at east corner along exterior of the northeast wall ; stairway consists of seven open wooden steps (29 1/2" wide x 9 1/2" tread x 8" rise) plus a riser of 7".

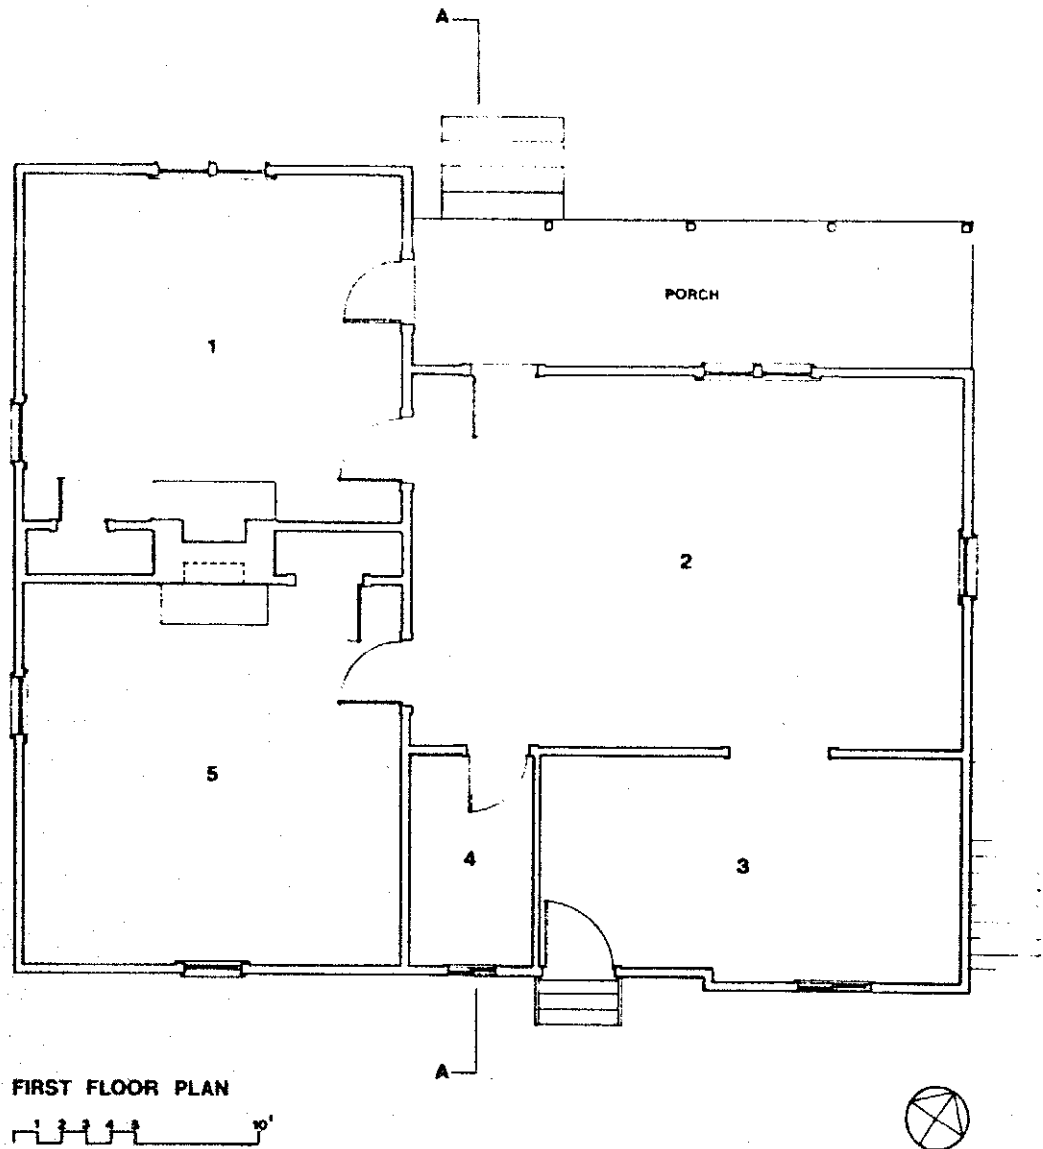
First floor plan of the Conrad House

At the time of its construction, the dwelling reportedly consisted of a living room, bedroom and kitchen (Rooms 1, 2 and 5) and a back porch (Room 4). Heat evidently came from back-to-back fireplaces in the living room (Room 1) and bedroom (Room 5) and from a wood/coal stove in the kitchen (Room 2).

### Interior Description: Room 1 (room numbers are keyed to plan on page 21)

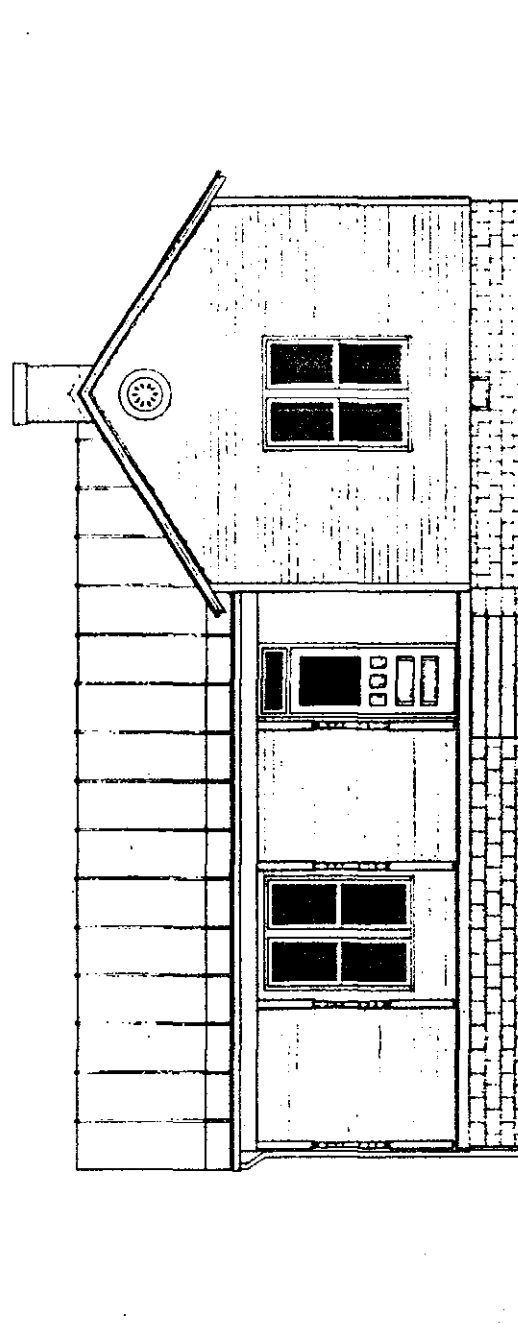
NORTHWEST ELEVATION

Northwest elevation of the Conrad House

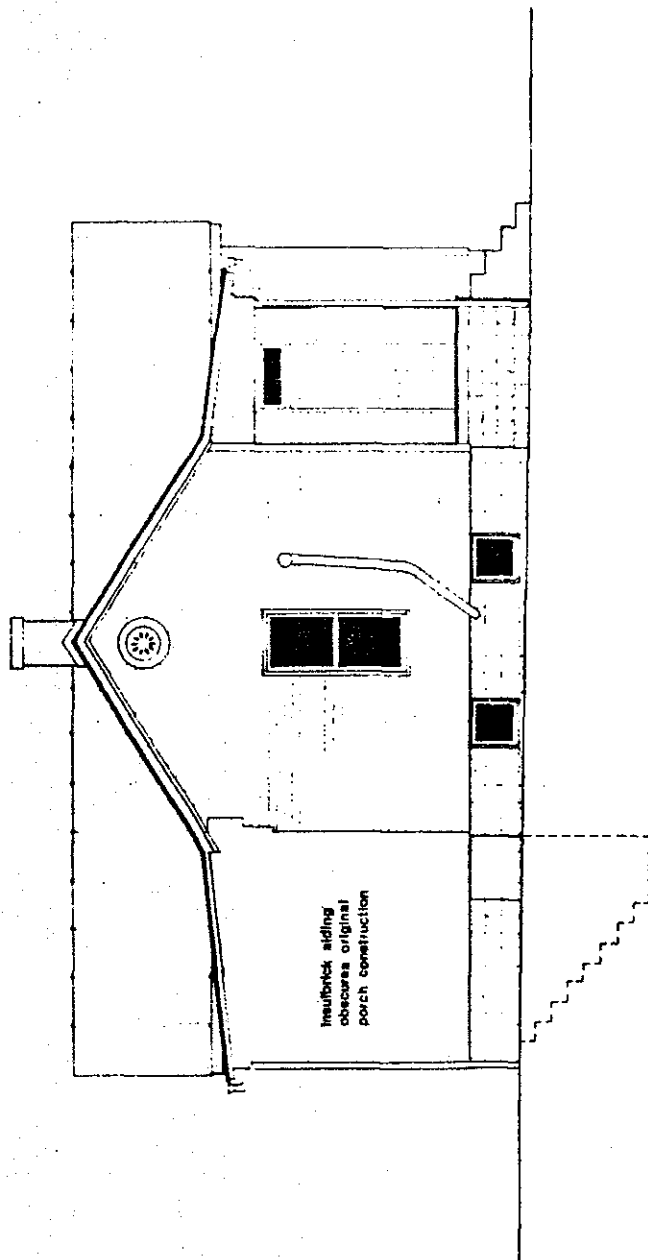
NORTHEAST ELEVATION

Northeast elevation of the Conrad House

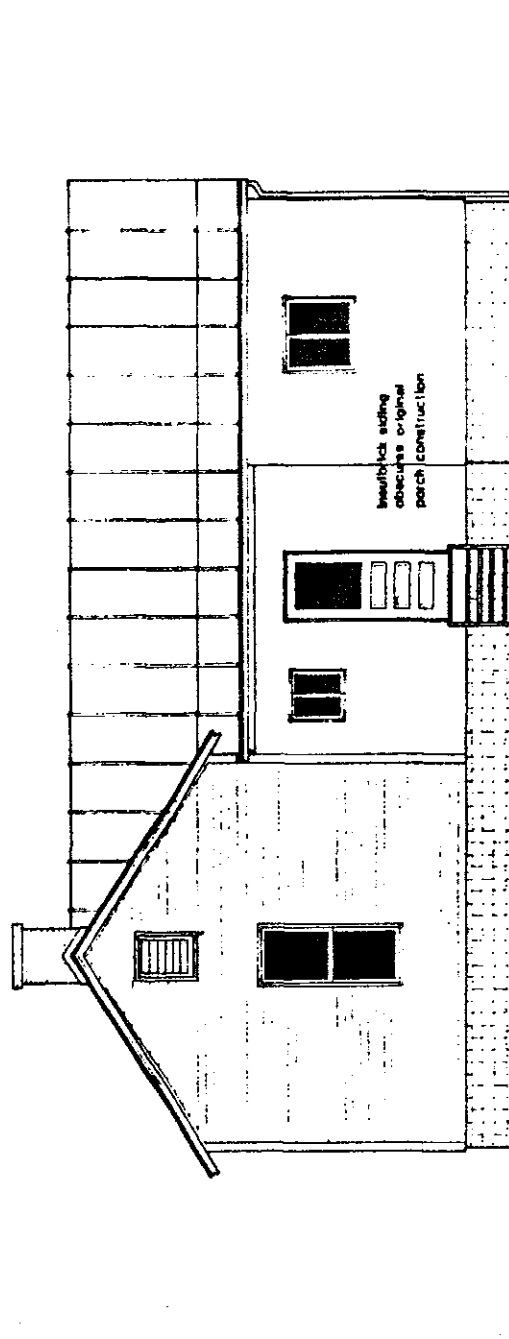
Southeast elevation of the Conrad House

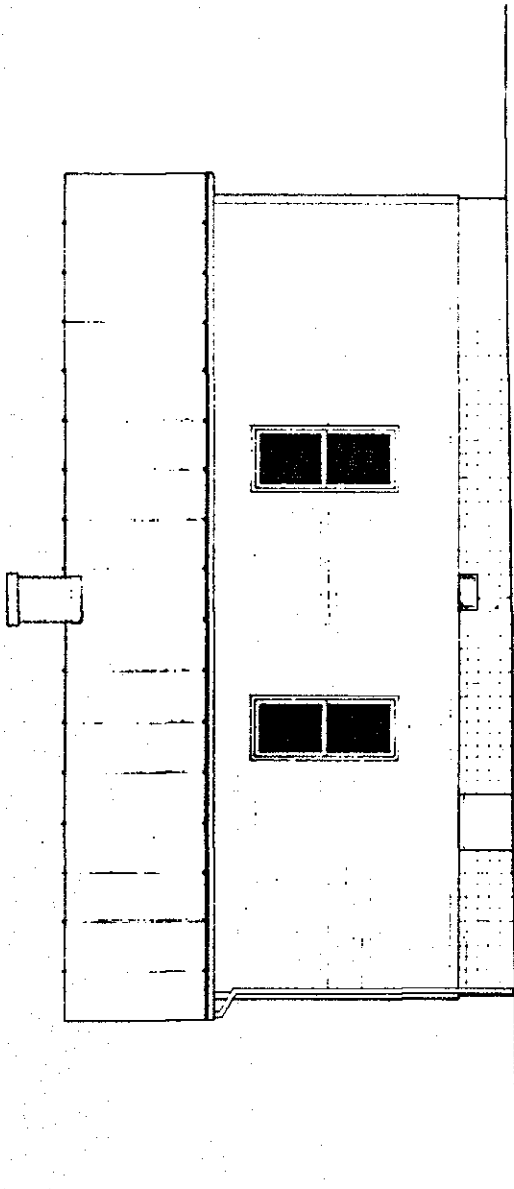
SOUTHWEST ELEVATION

Southwest elevation of the Conrad House

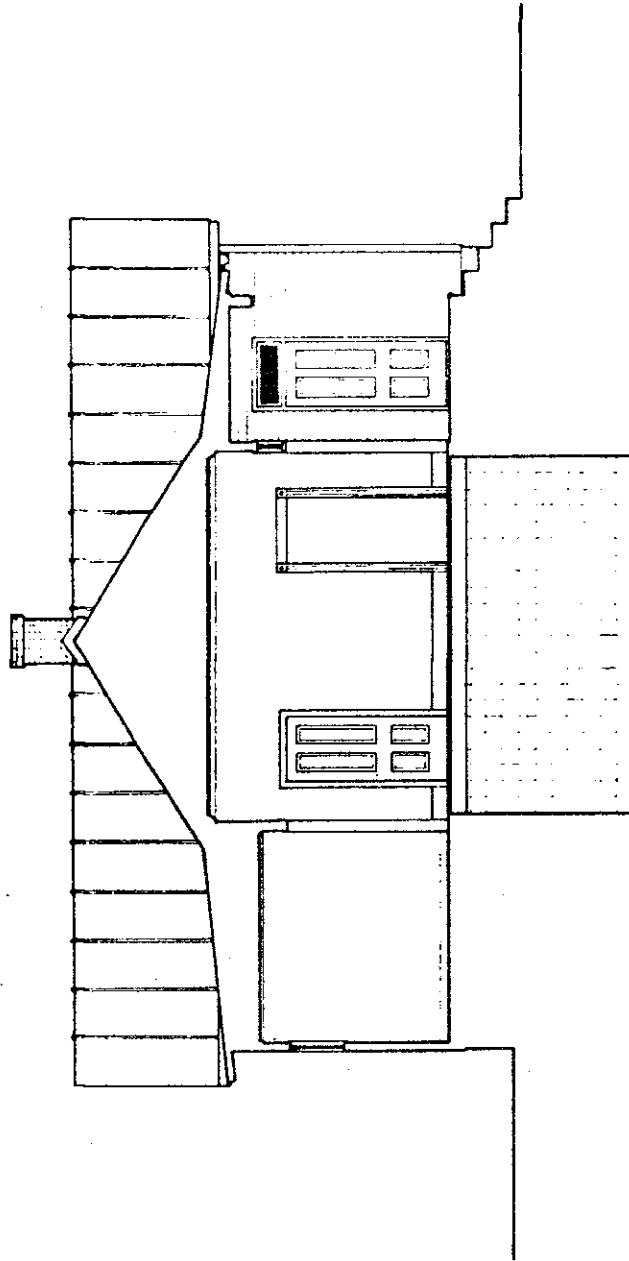
SECTION A-A

Longitudinal section (A-A) through the Conrad House

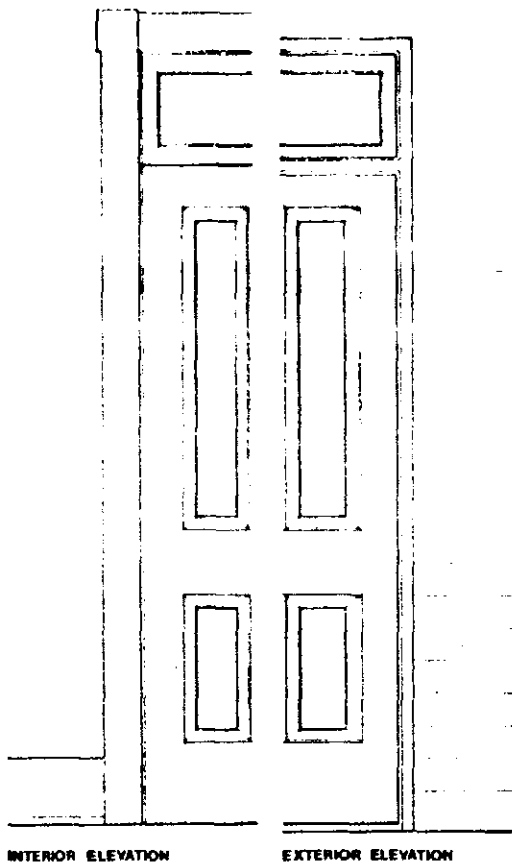
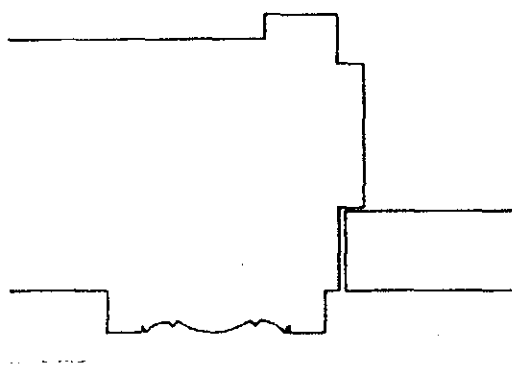
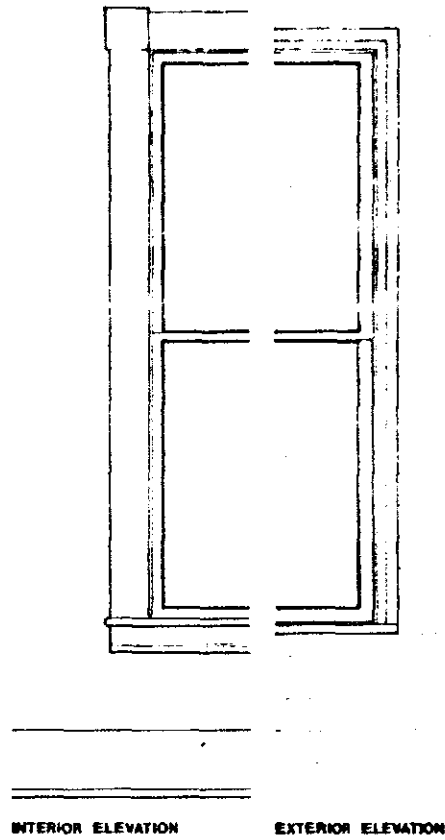
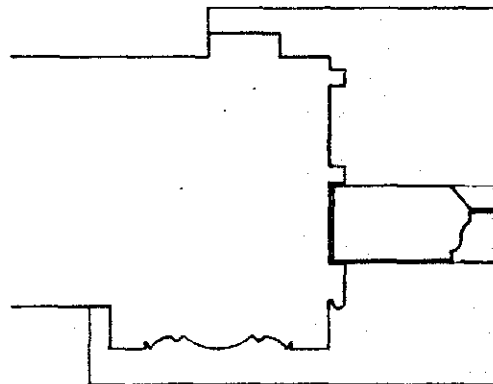
TYPICAL (TRANSOM) DOOR

TYPICAL DOOR MOLDING

TYPICAL WINDOW

TYPICAL WINDOW MOLDING

Typical architectural details in the Conrad House

Position	Opening	Style	Hinge	Latch/Lock	Interior Surround Trim	Exterior Surround Trim	Threshold
Room 1 to Porch	2'7 3/4" x 6'7"	4 panel; transom	3 1/8" pin butt	mortise lock	4 1/2" mold	4 1/2" plain boards	yes
Room 1 to Closet	1'11 3/4" x 6'7"	2 panel	3 1/2" pin butt	mortise lock	4" plain boards	2 3/8" ranch mold	no
Room 1 to Room 2	2'8" x 6'8"	door missing	3" butt	mortise lock	3 3/4" plain boards	4" plain boards	yes
Room 2 to Porch	2'8" x 6'7"	6 panel with top panel glass; transom	3" pin butt	mortise lock; modern mortise dead bolt	4 1/2" mold	4 3/8" plain boards	yes
Room 2 to Room 3	6' x 6'7 1/2"	passageway	—	—	4" plain boards	2 3/8" ranch mold	no
Room 2 to Room 4	2'7 3/4" x 6'9"	door missing	3 1/2" pin butt	mortise lock (modern)	4" plain boards	2 3/8" ranch mold	yes (missing)
Room 2 to Room 5	2'7 3/4" x 6'8"	4 panel	3" pin butt	mortise lock	3 3/4" plain boards	3 3/4" plain boards	yes
Room 3 to Exterior	2'7 1/2" x 6'8 1/2"	4 panel; top panel glass	3 1/2" pin butt	mortise lock	2 3/8" ranch mold	3 3/4" plain boards	yes
